IDENTIFICATION AND ANALYSIS OF LANDSLIDE SOIL VULNERABILITY AS THE BASIS OF DISASTER MITIGATION WITH GEODETIC MEASUREMENT METHODS AND QUANTITATIVE DESCRIPTION

DINDA PRATIWI DWI PUTRI¹, EDIYANTO², RIYAS SYAMSUL ARIF¹, JESSICA ASTRID KARTIKA², CAHYA RISKI FATHUROHMAN¹, DESSY APRIYANTI¹

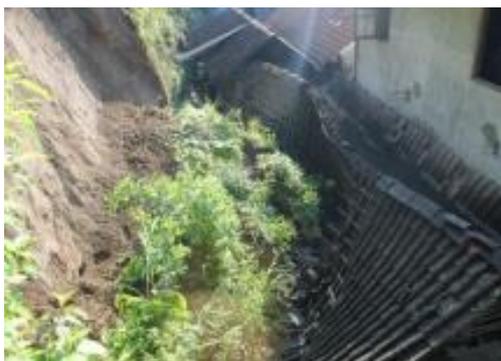
Figure 1. Landslide in Menjing Village, Jenawi, 2015.

The landslide that hit Menjing Village like presented in **Figure 1**, Jambon hamlet in 2014 and 2015 caused soil cracks and damage to houses and agriculture. In 2014 there were three landslides, 17 in 2015 there were six, and in 2017 three landslides (BPBD Karanganyar,

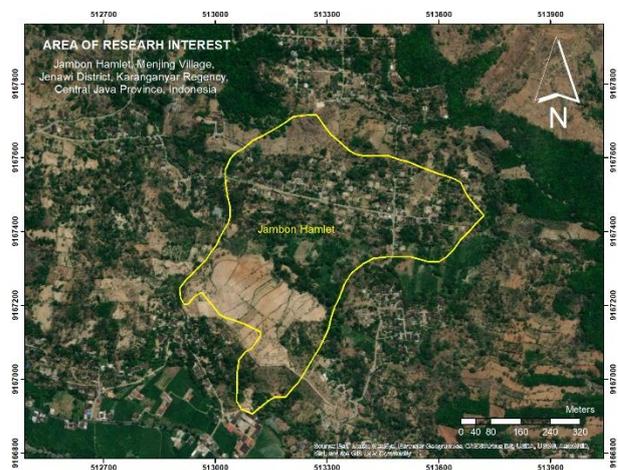
Figure 2. Area of Research Interest

The research area is located in Jambon Area, Menjing Village, Jenawi District, Karanganyar Regency, Central Java Province, Indonesia. This location was chosen because of its track record of landslides that are severe enough to destroy many buildings in the village. Area of research interest presented in **Figure 2**.

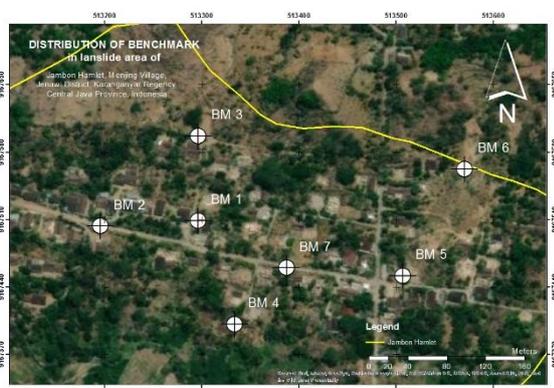
Figure 3. Distribution of Benchmark.

arrangement. The measurement parameters include an open area around an angle of 15 degrees and easily accessible, laying points that are safe and not easily damaged, BM (Benchmark) is made of concrete, for the distribution of points is evenly distributed and the distance between points bm forms an equilateral triangle net with the distance between the base points almost the same.

Data collection is carried out using GNSS measurement. Positioning of GNSS is obtained from tying back through measuring the distance of several satellites whose positions are known so that the position of the observer can be determined. Observations with GNSS technology produce coordinates in the geodetic coordinate system (ϕ , λ , h), three-dimensional Cartesian coordinates (X, Y, Z), and time parameters. In this study, measurements were made in January and June 2020 at seven control points for monitoring the movement of deformation, the distribution of these control points presented in **Figure 3**.
